iPod Nano 6 Display Breakout - Bug #601

TLV61220 footprint wrong

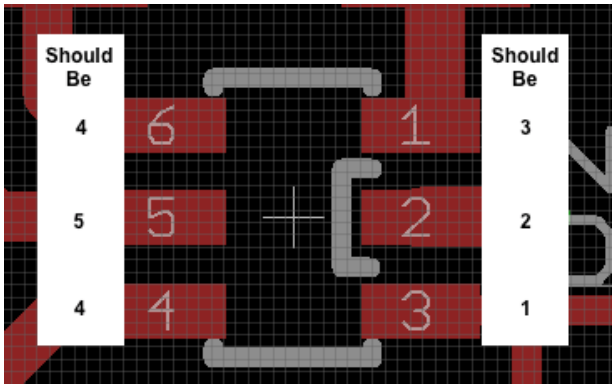
The SOT23-6 footprint I created is mirrored top-to-bottom (i.e. pin 1 is pin 3, pin 4 is pin 6).

Part doesn't work for us anyway, see #602

The layout'll have to be fixed. I've updated the library but I wonder what other SOT23-6 parts I have that are wrong.

For now the fix for this board is to take the pins and bend them backward and mount the part upside down.

Footprint fixed in commit:122c7eb.
